## *Test Reports of Immunity*

*(EN55024/2010)*

Model : ECOSYS M6535cidn

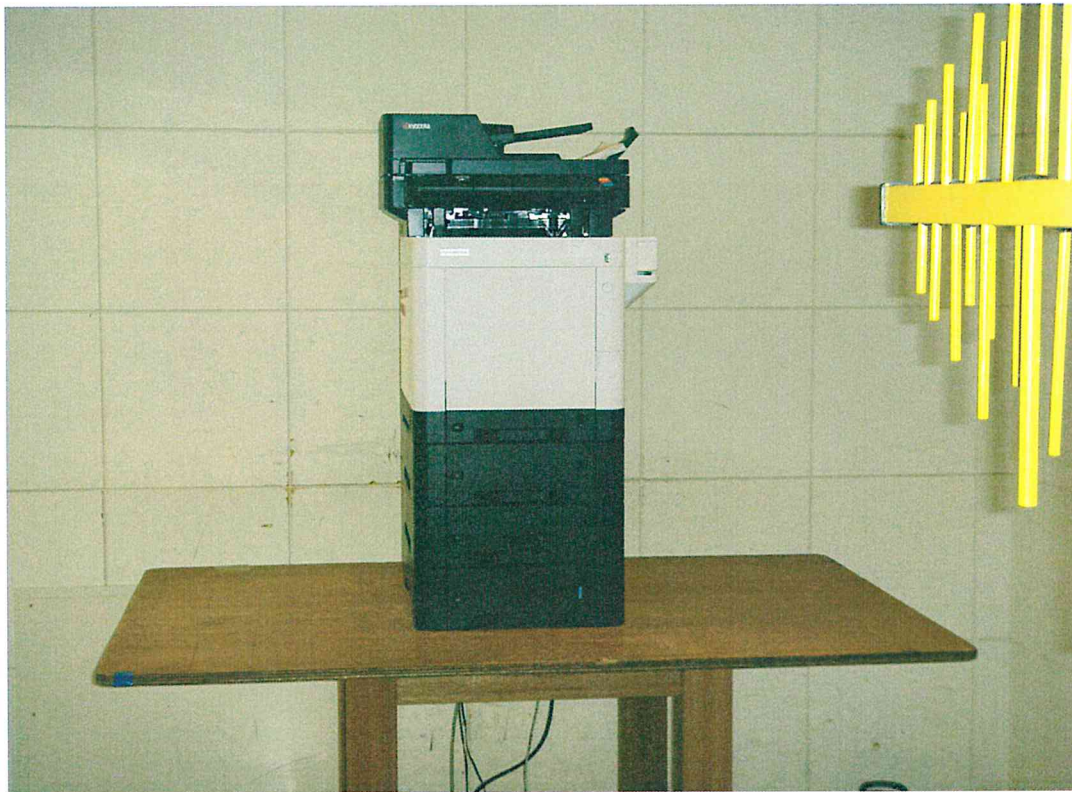
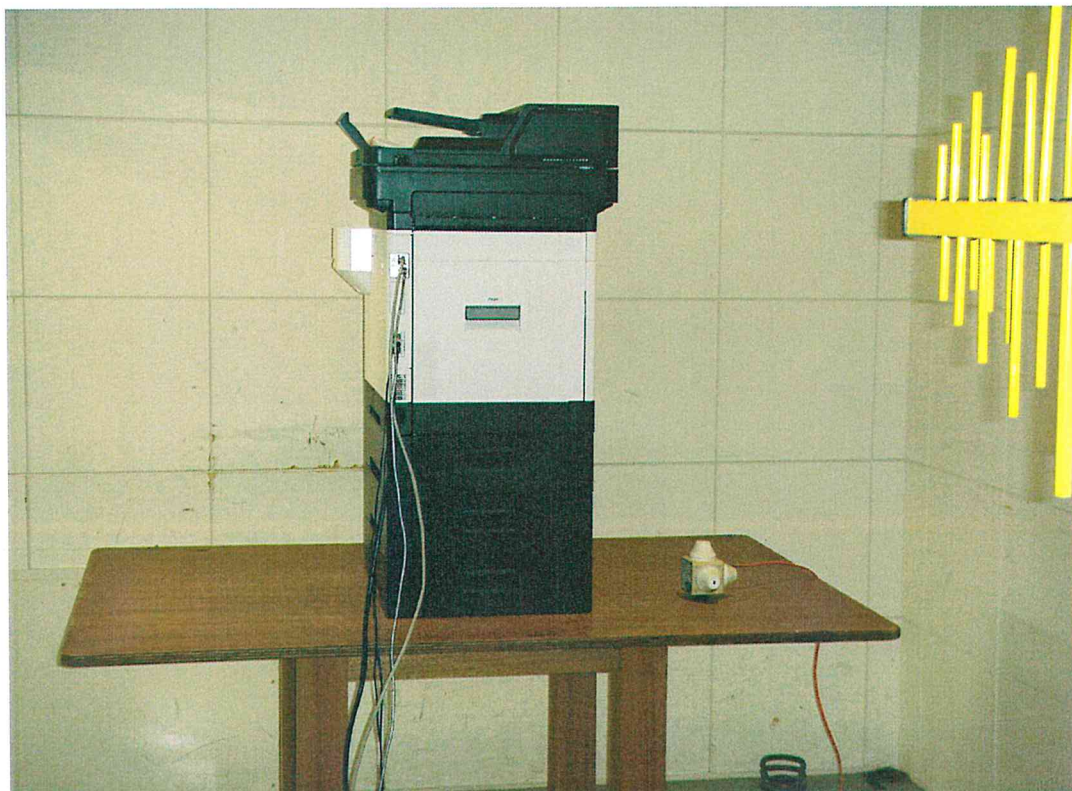
## **Photograph of Tested Device Configuration**

**(Radiated RF Electromagnetic Field Immunity Test)**

<i>Frequency</i>	<i>Polarity</i>	<i>RF Level</i>	<i>Criteria</i>	<i>Result</i>
80~1000 MHz	Vertical	3V/m, 80%, 1kHz AM Modulation	A	Pass
	Horizontal			Pass
900±5 MHz	Vertical	3V/m, 100%, 1kHz Frequency 200Hz Duty Cycle 50% PulseMod.	A	Pass
	Horizontal			Pass

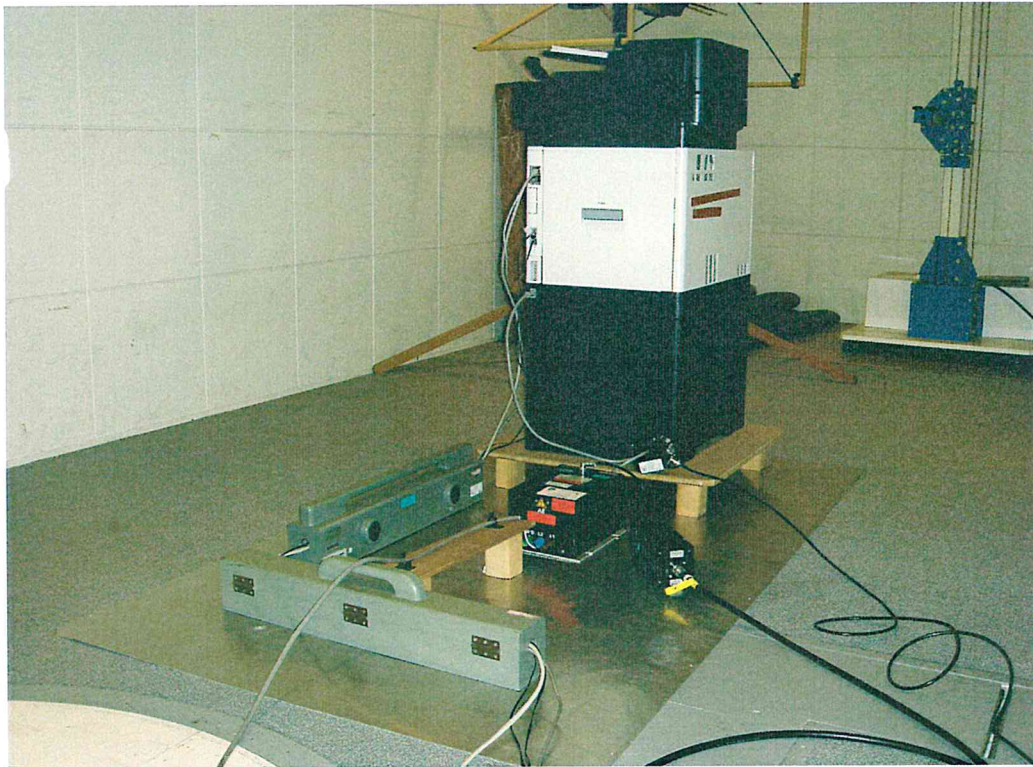
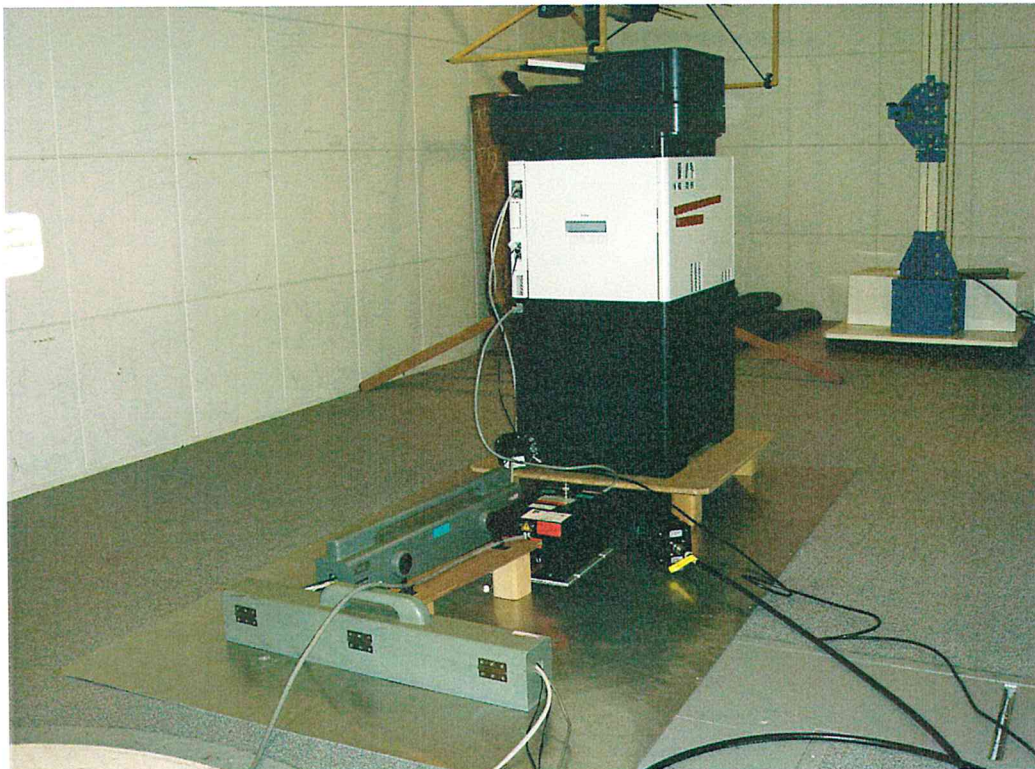
## ***Photograph of Tested Device Configuration***

**(Conducted RF Electromagnetic Field Immunity Test)**

<i>Tested Port</i>	<i>Coupling</i>	<i>Operation Mode</i>	<i>Result</i>	<i>Remarks</i>
AC Power Cord for Printer	CDN M3	Copy	<i>EUT worked normal.</i>	
LAN Cable	EM Clamp	LAN Print (On Board)	<i>EUT worked normal.</i>	
USB Cable	EM Clamp	FAX Tx + USB Print	<i>EUT worked normal.</i>

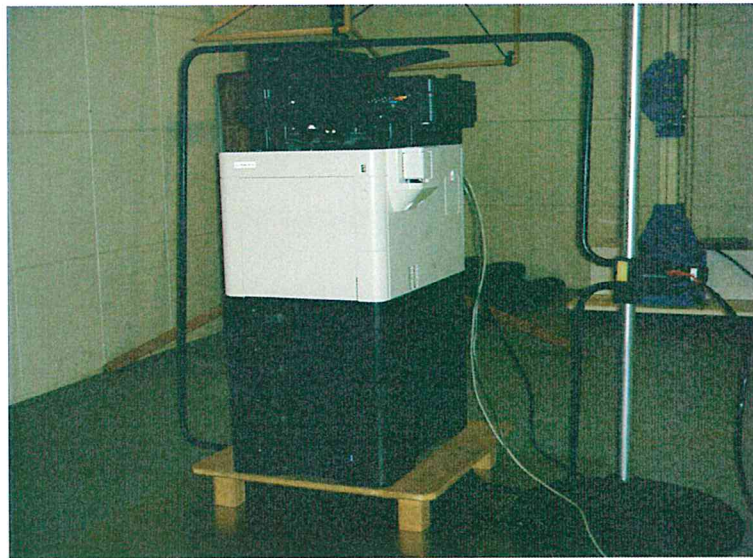
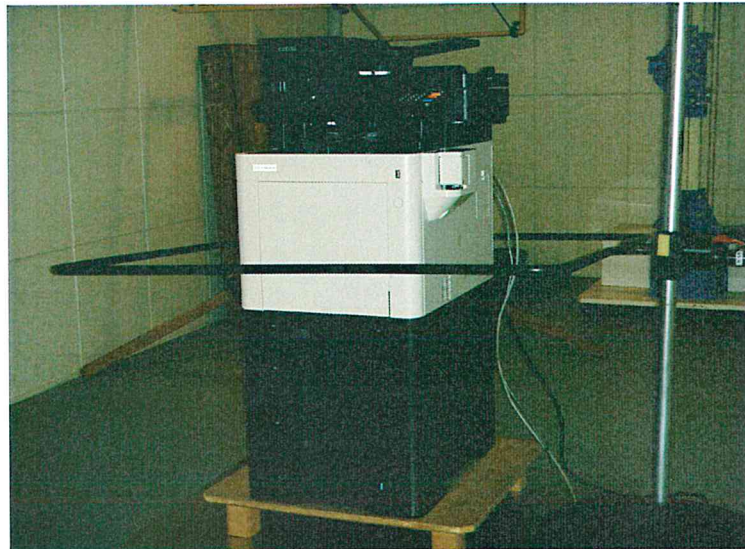
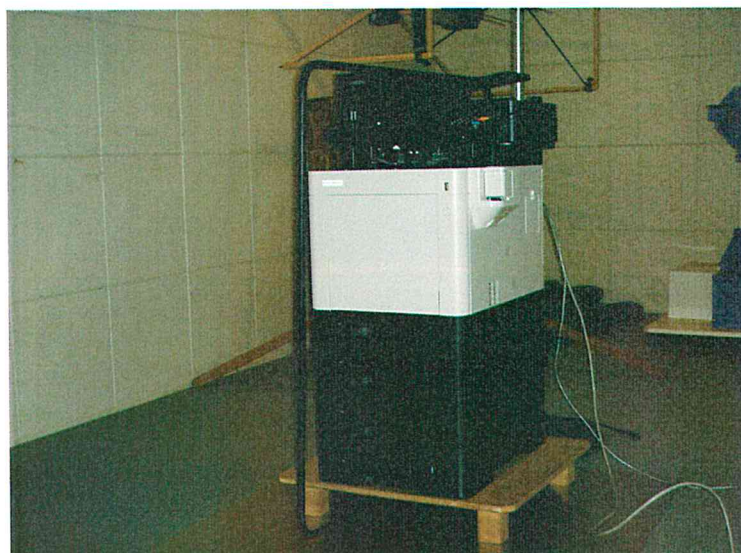
## ***Photograph of Tested Device Configuration***

**(Power-Frequency Magnetic Field Immunity Test)**

<i>Polarization</i>	<i>Operation Mode</i>	<i>Result</i>	<i>Remarks</i>
X	Copy	<i>EUT worked normal.</i>	
Y	Copy	<i>EUT worked normal.</i>	
Z	Copy	<i>EUT worked normal.</i>
