## *Test Reports of Immunity*

*(EN55024/2010)*

Model : TASKalfa 306ci

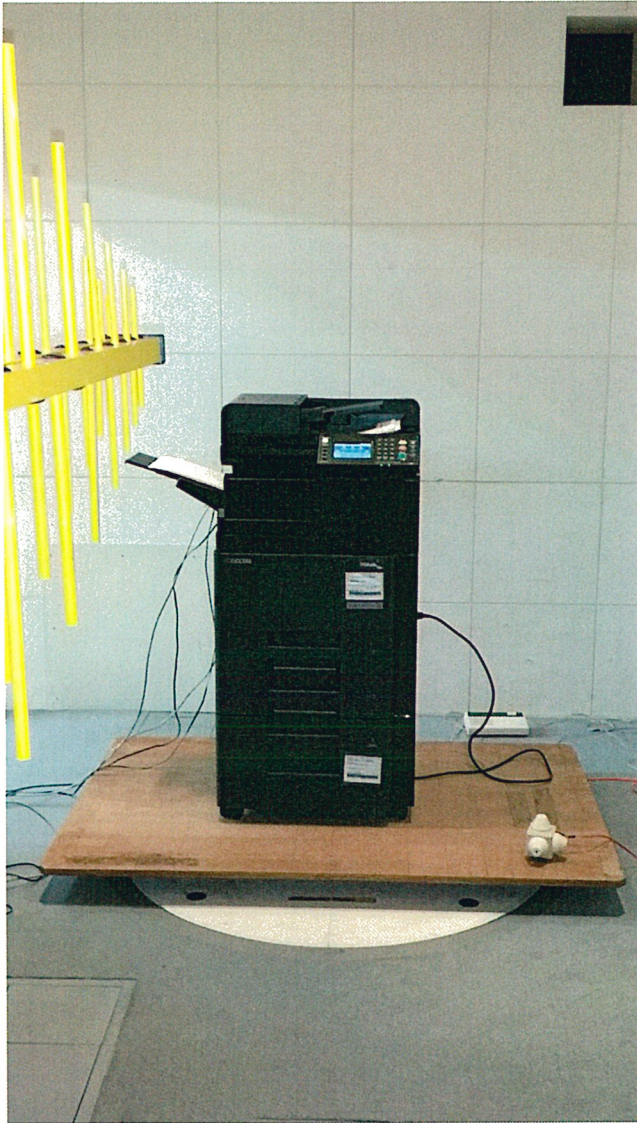
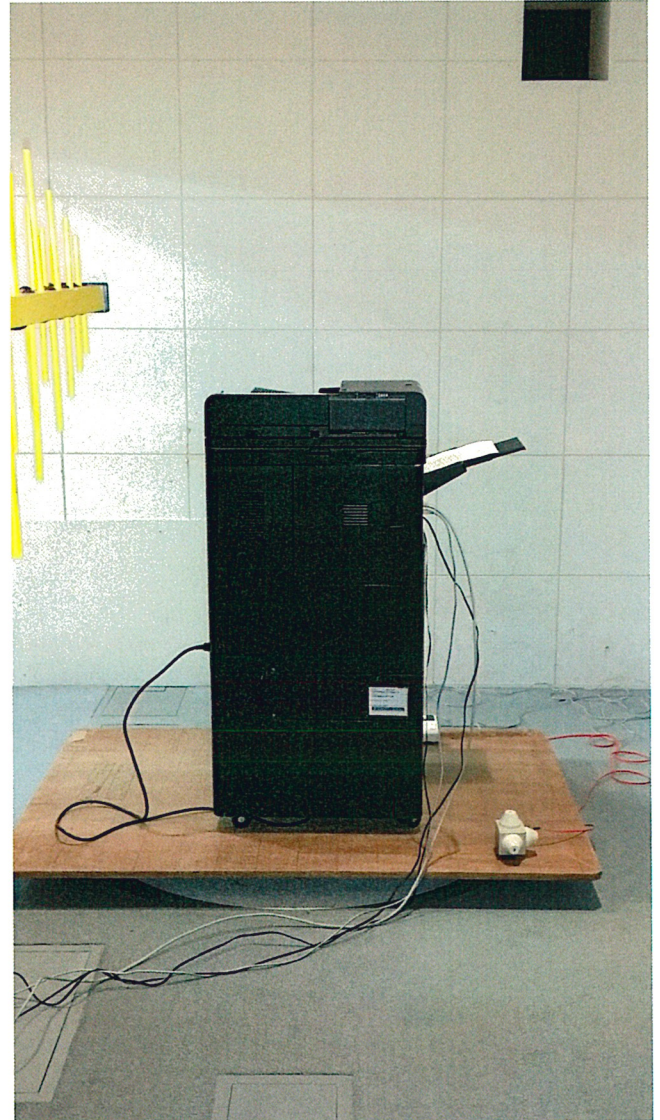
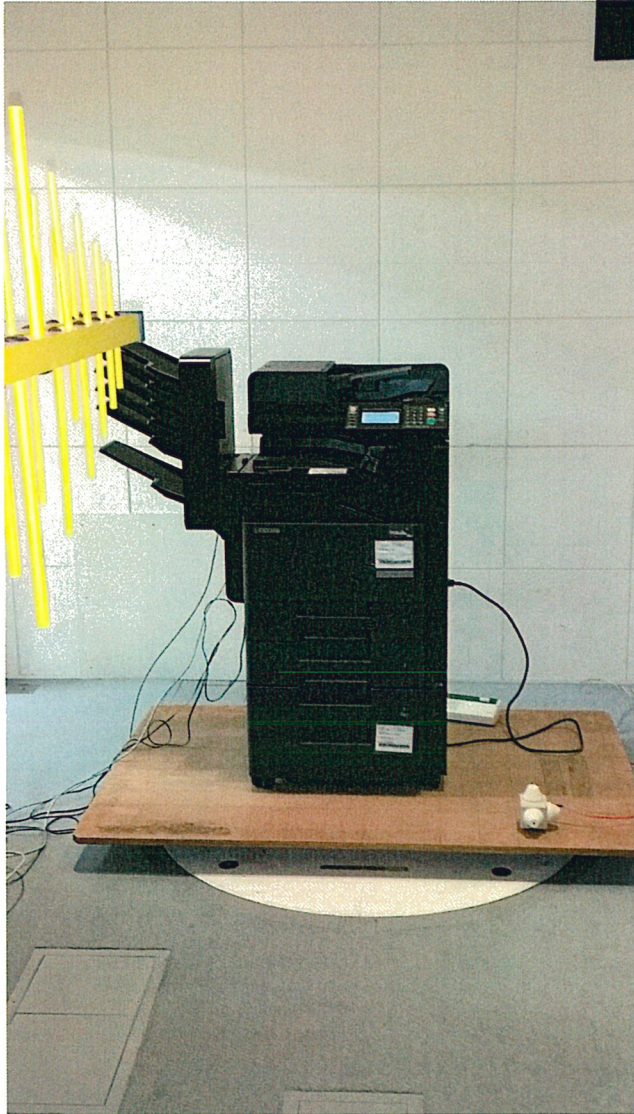
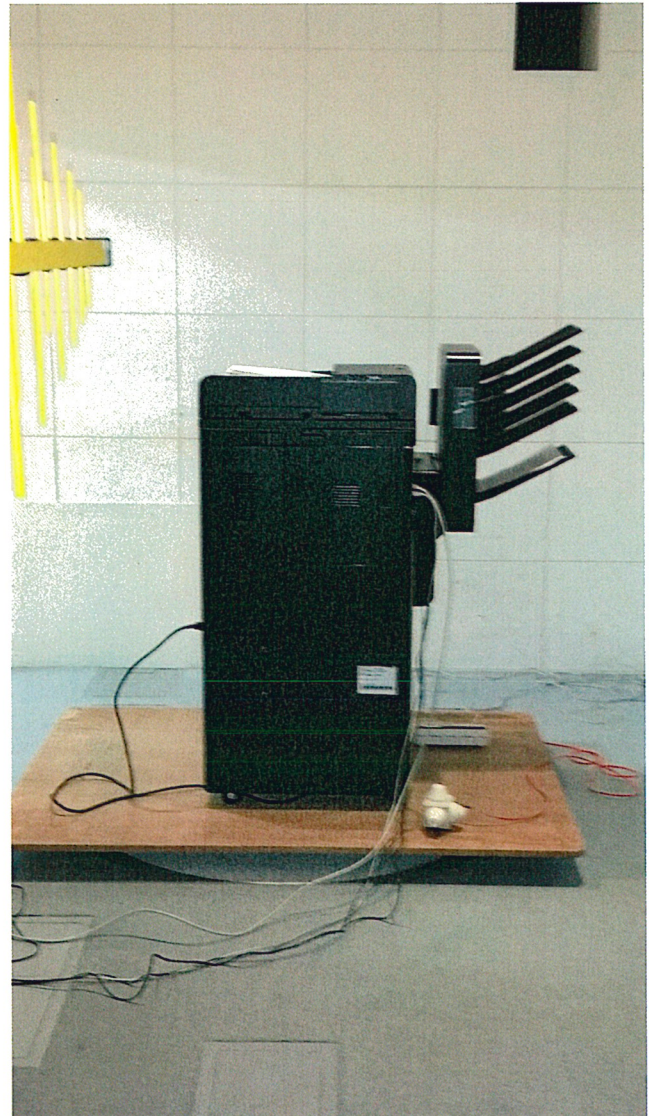
## **Photograph of Tested Device Configuration**

**(Radiated RF Electromagnetic Field Immunity Test)**

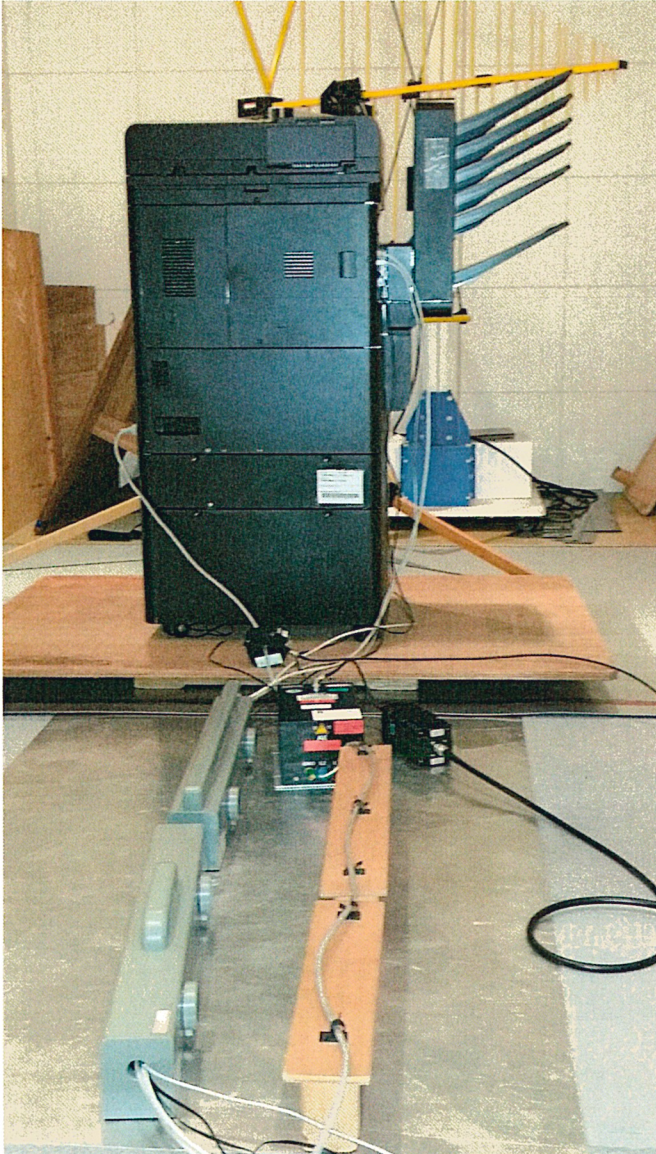
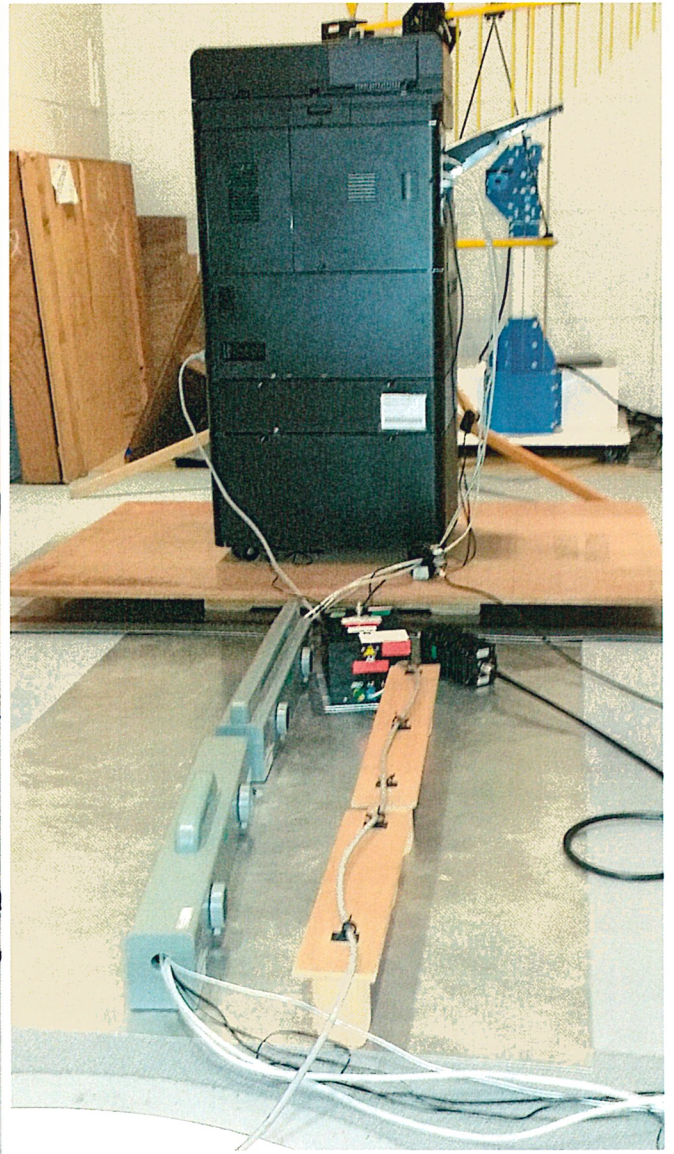
## **Photograph of Tested Device Configuration**

**(Conducted RF Electromagnetic Field Immunity Test)**

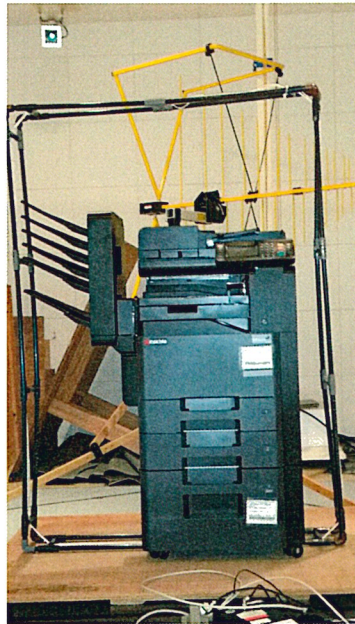
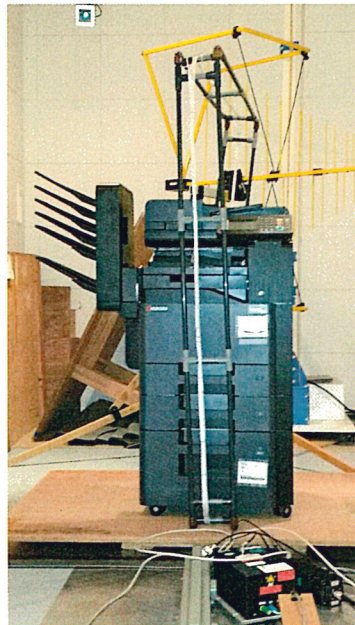
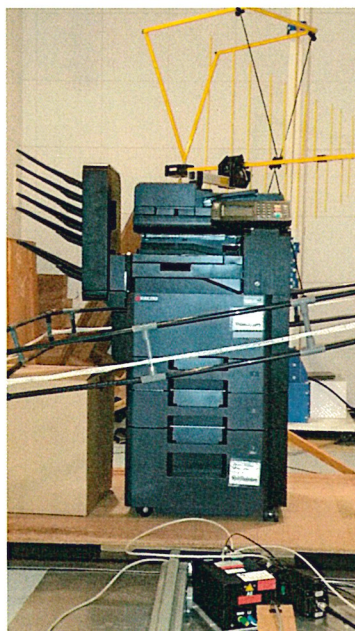
## **Photograph of Tested Device Configuration**

**(Power-Frequency Magnetic Field Immunity Test)**
